Antoni KOMOROWSKI¹, Iwona PIETKIEWICZ²

The Świna estuary navigation marks changes after 1793

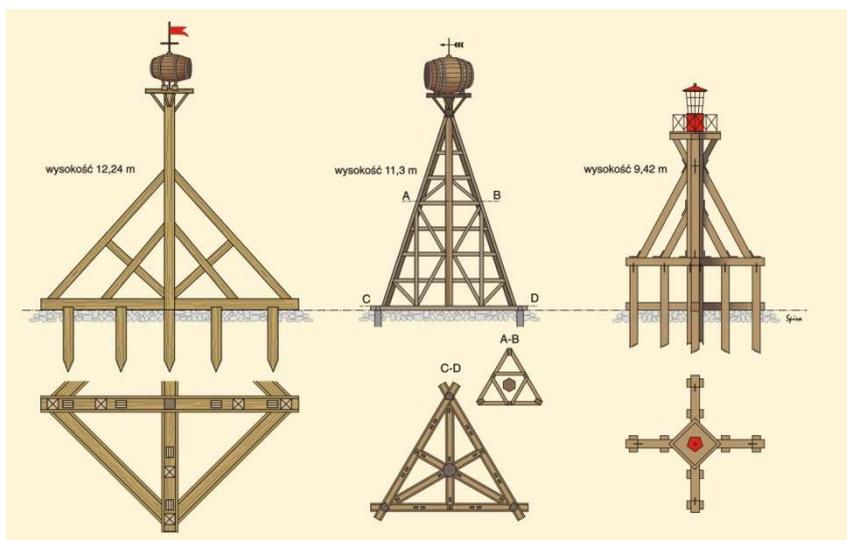
Fig. 2. Reconstruction of wooden beacons from 1805
Source: Authors collection

The description of the first lighthouse at the entrance to the Świnoujście port in 1805 reads: "In spring 1805, a lighthouse called Leuchtbude was lit on the head of the east breakwater. It was a wooden construction with a fire kindled on top, amplified using a system of mirrors reflecting the light" [2]. This describes the first construction of a fixed entrance beacon, an image of which was found in the State Archives in Szczecin [15], shown in Fig. 2. The weak light emitted by candles or an oil burner was amplified using a polished metal mirror, described in the archives as a system of mirrors. Until the construction of the lighthouse in Chorzelin (a district in Świnoujście), entrance lights played a key role in the Świnoujście port.

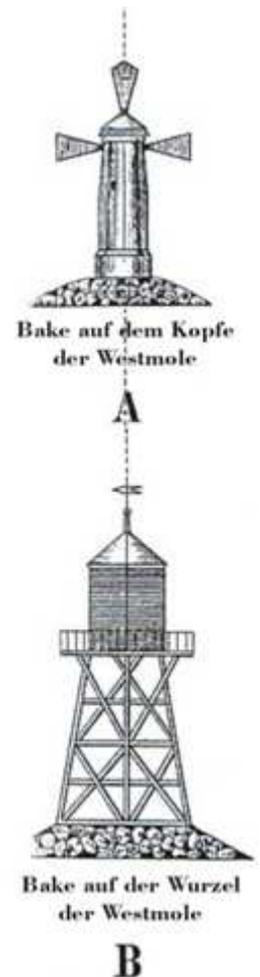
Fig.3. Beacons of entrance leading lines „Młyny”and „Galeriowa”.
Source: Authors collection

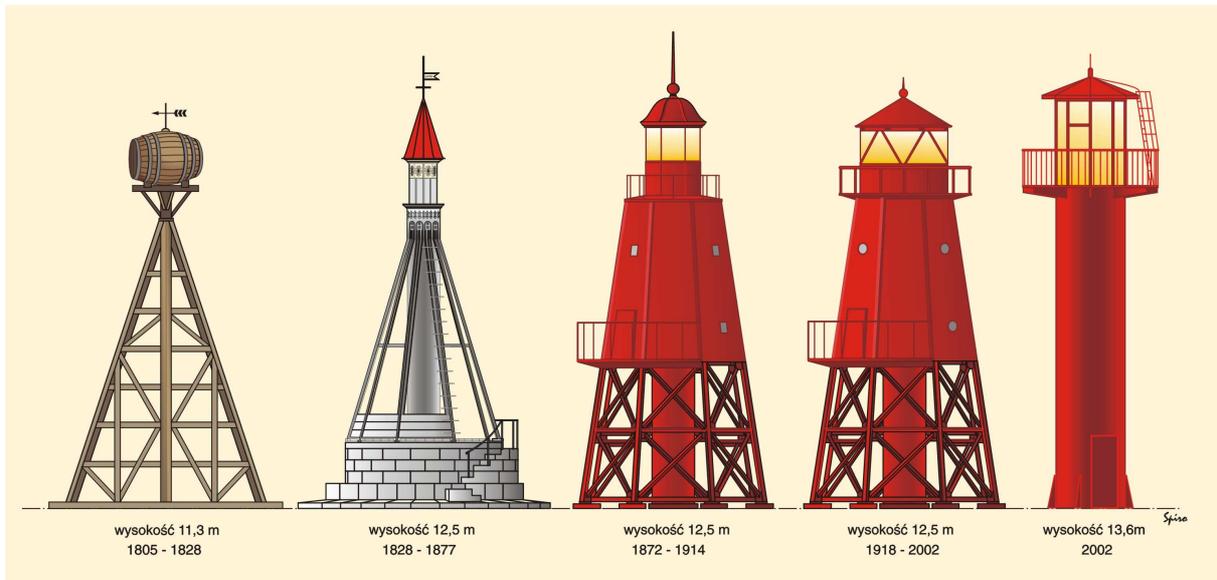
Fig. 4. Reconstruction of entrance beacons of the eastern breakwater

Two stone breakwaters were built between 1818-1823 in the Świna estuary, changing navigation at the entrance to the port. New navigational aids were also introduced: the second entrance beacon, made of iron, 12.5 meters tall (Leucht-Baake), situated at the end of the east breakwater (1828), fitted with an Argand lamp with five reflectors in two rows, lighting a sector of 180° with a permanent light with a reach of 2.5 miles (Fig. 4) [7]. A maritime pilot's station was opened on the west river bank.

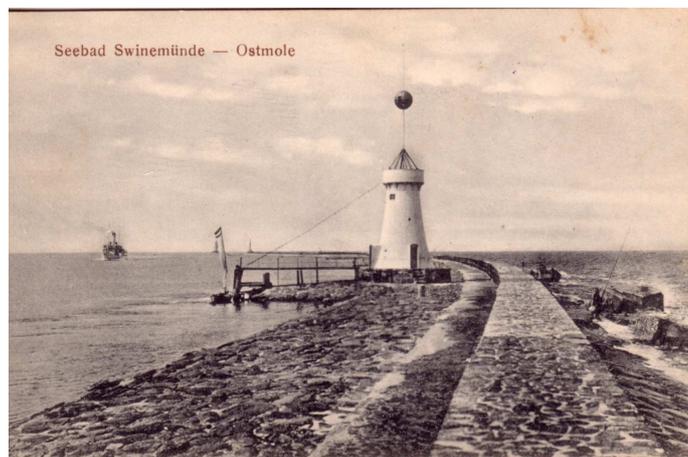
Fig. 5. The „Winkbake” beacon on copie of old postcard

The next navigational aid placed in the central part of the eastern breakwater was the Winkbake beacon (Fig.5). Its wooden construction was frequently changed, and the one built in 1814 was modernised as soon as 1857. For many years the Winkbake beacon, together with the beacon on the eastern Świnoujście beach (Richtungsbake, Richtbake or Landbake⁷), formed the line of leading lights at the port approach with a true bearing of 146.2°. The leading light was removed following the modification of the channels leading into the port⁸.

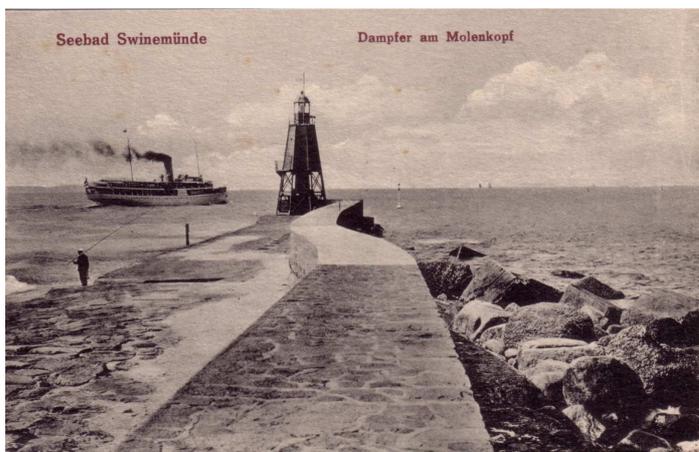
Fig. 6. Entrance beacon (3) on eastern breakwater

The stone breakwaters, approximately 1000m (western) and 1300m (eastern) long, were exposed to frequent storms causing gradual damage. As a result, works aiming to repair and extend the western breakwater were initiated in 1866. It was extended to 1491m, and a new iron entrance beacon measuring 14.25m was constructed on its head between 1872-1875. The old entrance beacon remained in place for some time, so the breakwater actually had two lights, shown on old maps and postcards from the period. The new entrance beacon

was an octagonal pyramid, tapering towards the top, with a dome-shaped prism lantern⁵ placed on top. Analysis of a cross section of the building gave following details: the base was constructed from granite blocks and anchors, with two levels of steel ribs with an obtuse section attached on top. The centre of the beacon, up to the height of 6.3m, was a forged iron cylinder 1.3m in diameter with an entrance and iron staircase leading to the service room. The interior of the cylinder also housed a manual hoist. The keeper's room, with insulated and wood-paneled walls, was located above the service room. The top section of the keeper's room held a cylindrical hatch 0.55m tall used for accessing the lantern room. The uppermost part of the cylinder was closed using a double door. The lantern room had eight glass panels. It housed the fire specially ordered Fresnel lens and a mineral oil burner emitting red light with the use of a filter. Its arc of visibility was 360°. The height of the light beam above sea level was 13m, and it had a range of 10.6 miles. A bell mounted on the outside of the beacon was used to transmit fog signals. The total cost of the construction of the new beacon was 22,527 marks, with the Fresnel lens costing 2,760 marks. A total of 11,918 kg iron, 7,639 kg sheet iron and approx. 10,000 rivets were used in the construction [5].

The third harbour light (Fig.6) survived until the outbreak of the First World War, although it was disassembled or destroyed in 1914⁶. After the end of the war, in 1918 a new (fourth) lighthouse was erected in its place with a similar iron construction, slightly broader, and with a different roof construction. The fog bell was replaced with a multi-segment acoustic nautophone. The lighthouse survived many years and was modified several times. It was eventually replaced with the fifth construction in 2002, with a temporary light mounted on a 4.3m pole used during the works.

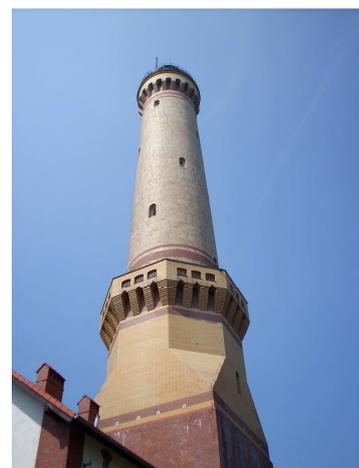
Fig. 7. Świnoujście lighthouse – contemporary view.

The octagonal tower of the Świnoujście lighthouse, together with the spiked domed roof, was 68m tall. The external surface of the tower was finished in yellow brick from the nearby Stettiner Haff brickyard, although the finish turned out to have low resistance to atmospheric conditions following years of use. The tower was considered for renovation works as early as 1869. During the meeting of the Architects' Association in Berlin on 21 November 1869 plans were presented outlining renovation works and principles of constructing scaffolding and a special hoist for lifting building materials onto the gallery [10]. Severe weathering was observed, resulting in bricks falling off, leading to conservation works in 1886 and 1899. Some sections of masonry were weathered and cracked to depths of 0.75m. Unfortunately the renovation works did not improve the situation, and the peeling brickwork continued to be a danger in the vicinity of the tower. As a result a decision was taken to carry out a general overhaul of the lighthouse tower between 1902-1903. During the works the profile of the tower was changed from octagonal to oval, and the weathered bricks were knocked off. The sheet iron gallery balustrade was also changed to an openwork metal construction to reduce wind resistance. Following the renovations and changes, the top section of the lighthouse tower was oval-shaped, becoming a quadrangle and octagon towards the bottom. The external layer was formed by clinker bricks from the Skromberg factory in Sweden, while the dark finish elements originated from the H. Zastrow factory in Wittemberg. In order to reinforce the new construction, the walls were fitted with 29x30cm mortices, which created a strong support linking the old core to the new elevation. The total cost of renovation works was 79,500 marks. The works were overseen by Messrs Riepe, Ruhtz and Jacobi under the direction of the engineer Kohlenberg [11]. The lighthouse continued to function for many years following the renovation works, although its optical

The Świnoujście lighthouse is the tallest along the Baltic coast and one of the tallest lighthouses in the world. The lower part of the tower, up to 16m, has a square cross-section 8.8m per side. Higher up the cross-section becomes octagonal, with the shape becoming regular and culminating with a lower viewing gallery at 22.5m, supported by 24 ceramic brick brackets and surrounded with a brick balustrade with decorative grating. Above the gallery the tower has a circular cross-section with the diameter decreasing from 7.4m to 6.6m. However, the internal diameter of the tower is constant at 4m. This effect was achieved by changing the wall thickness from 1.7m above the lower gallery to 1.3m at the upper gallery. The tower's main gallery is at 60.9m. It is supported by arcaded brick cornices and surrounded by a wrought iron balustrade. The gallery and lantern can be reached by climbing over 300 steps, which are readily scaled by visitors enjoying the glorious views from the upper gallery.
